REPORT NO: 1912

# REPORT ON THE TESTING OF WT-1 LIQUID MEMBRANE TO ETAG 022, ANNEX E

# Report on the testing of

# WT-1 Liquid Membrane

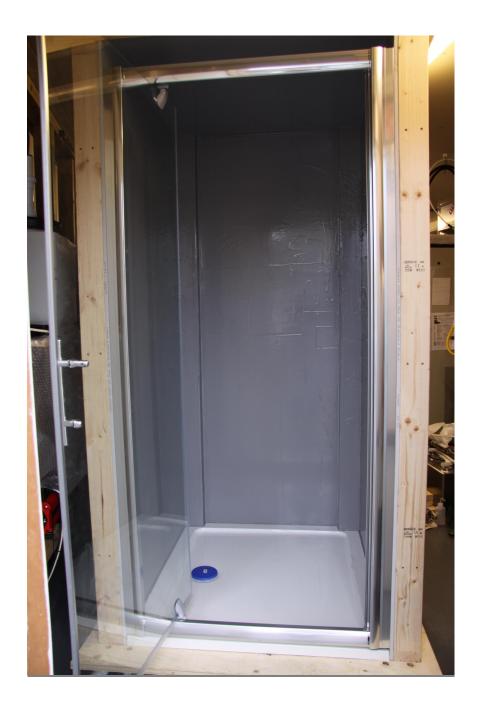
The test rig consisted of a chamber with 3 solid walls constructed of plaster board and one wall being a glass door (as in a shower cubicle). The chamber was 2.3m in height. There was a ventilation gap at the base of the door and at the top near the ceiling for air circulation. The walls of the chamber were coated with WT-1 Liquid Membrane by a representative of the customer, C-Tec, following the manufacturer's instructions.

### Photo to show Chamber coated with the WT-1 Membrane

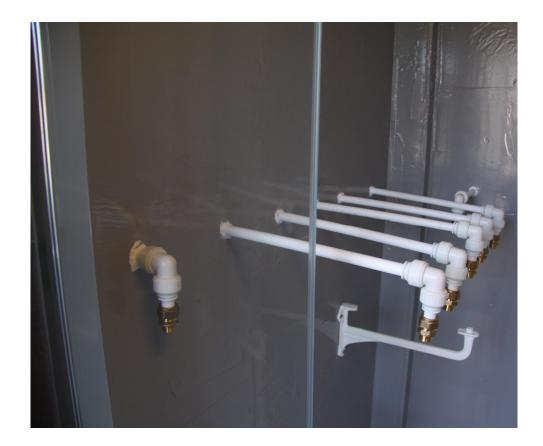
4 water pipes and 1 drainpipe are allowed to penetrate the wall, 2 of the pipes simulate hot and cold feeds to a basin and are fixed perpendicular to the surface of the wall. The other 2 water pipes are PEX pipe connected via junction boxes mounted according to the supplier's description. The ends of the pipes are plugged.

Two supports for a wash basin are mounted ~ 0.8 metre above floor level.

# Cabinet with plumbing

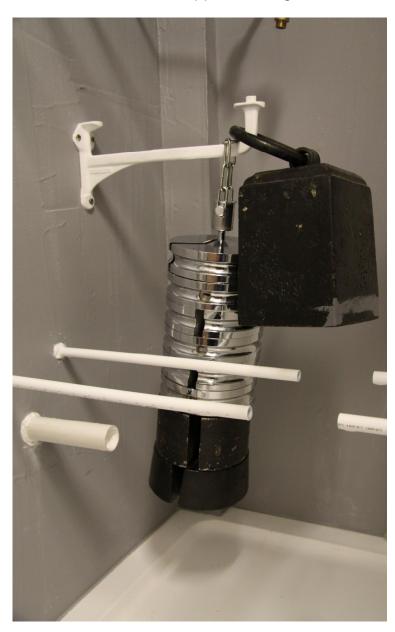
A static load of 750N (76.5Kg) is applied to each of the wash basin supports and held in position for 5 mins following which they are removed. Any deflection of the supports is measured at a distance of 300mm prior to the weights being added and 10 mins after removal.

To show support loading

There was no deflection of the supports following removal of the static load and no damage to the Coating was visible.

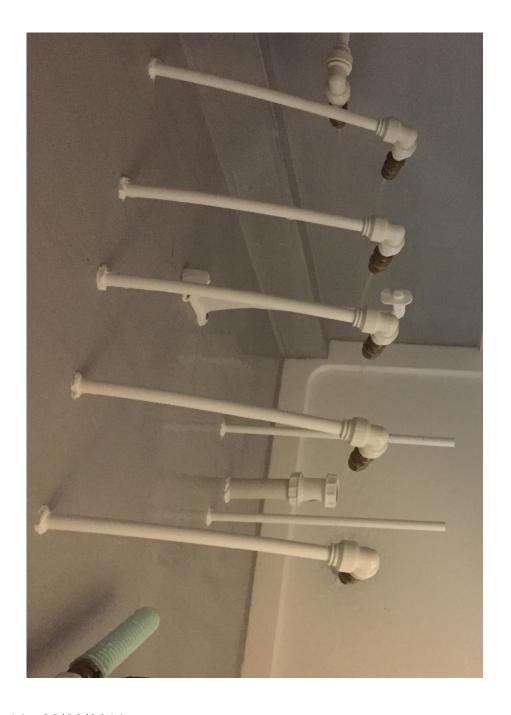
A second spraying regime of 1500 cycles is carried out after which measurements for water ingress are taken. A visual inspection to look for any change in appearance of the Coating or possible water penetrations of the chamber is carried out. The test chamber is then dismantled and further readings and visual inspections carried out.

There was no moisture ingress recorded at predetermined points after the test was completed.

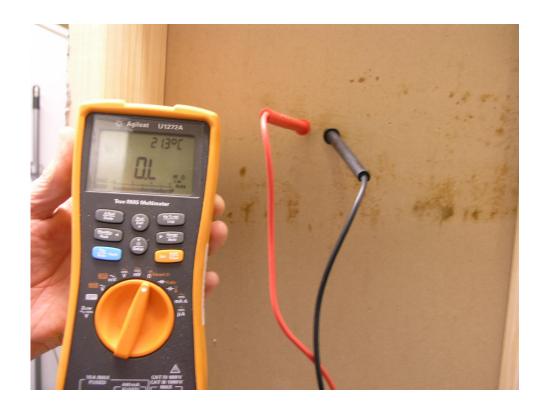
On dismantling the chamber after completion of the testing there was no evidence of water penetration through the chamber walls.

To show no moisture present through the chamber wall following completion of testing
